2001 Annual Compliance Report Falls City, Texas, Disposal Site

Compliance Summary

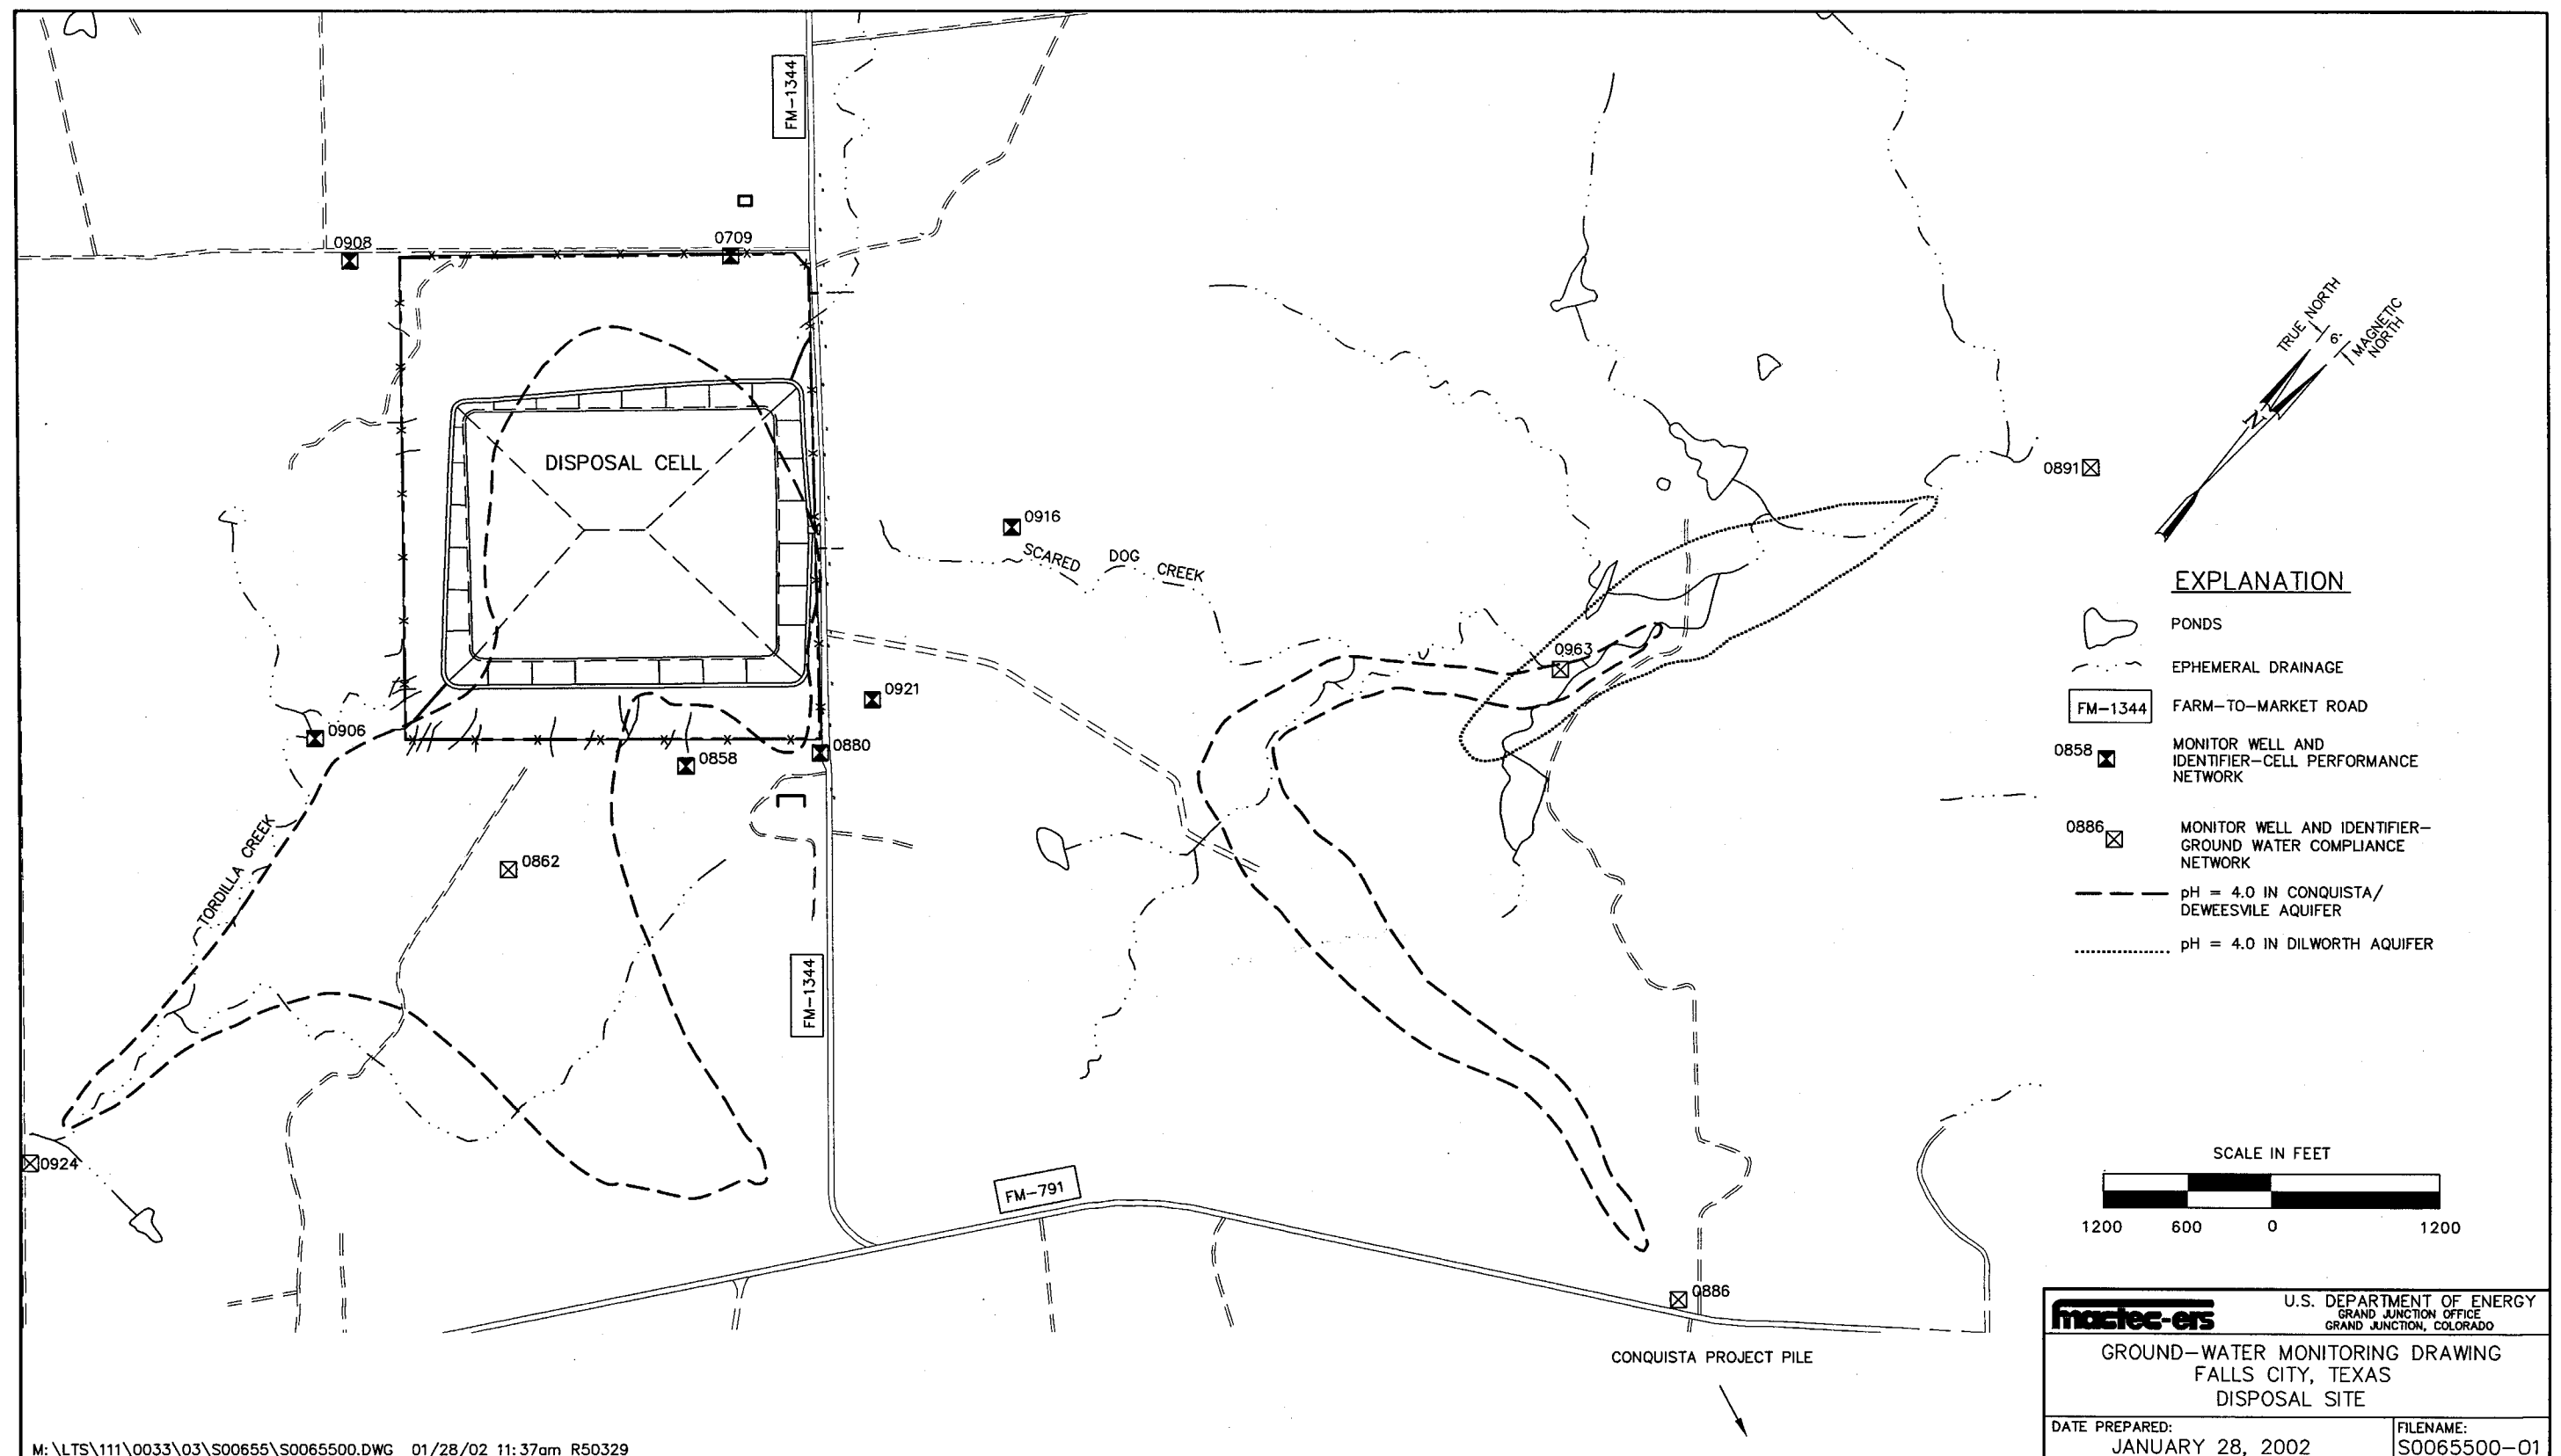
Figure 5-2. Ground-Water Monitoring, Falls City, Texas, Disposal Site

Two plumes are identified (see Figure 5–2). The east plume affects the Conquista/Deweeseville aquifer and the underlying Dilworth aquifer. The west plume, underlying the cell, also affects the

Conquista/Deweeseville aquifer, although elevated concentrations of some analytes had historically been observed in the Dilworth aquifer at well 0862.

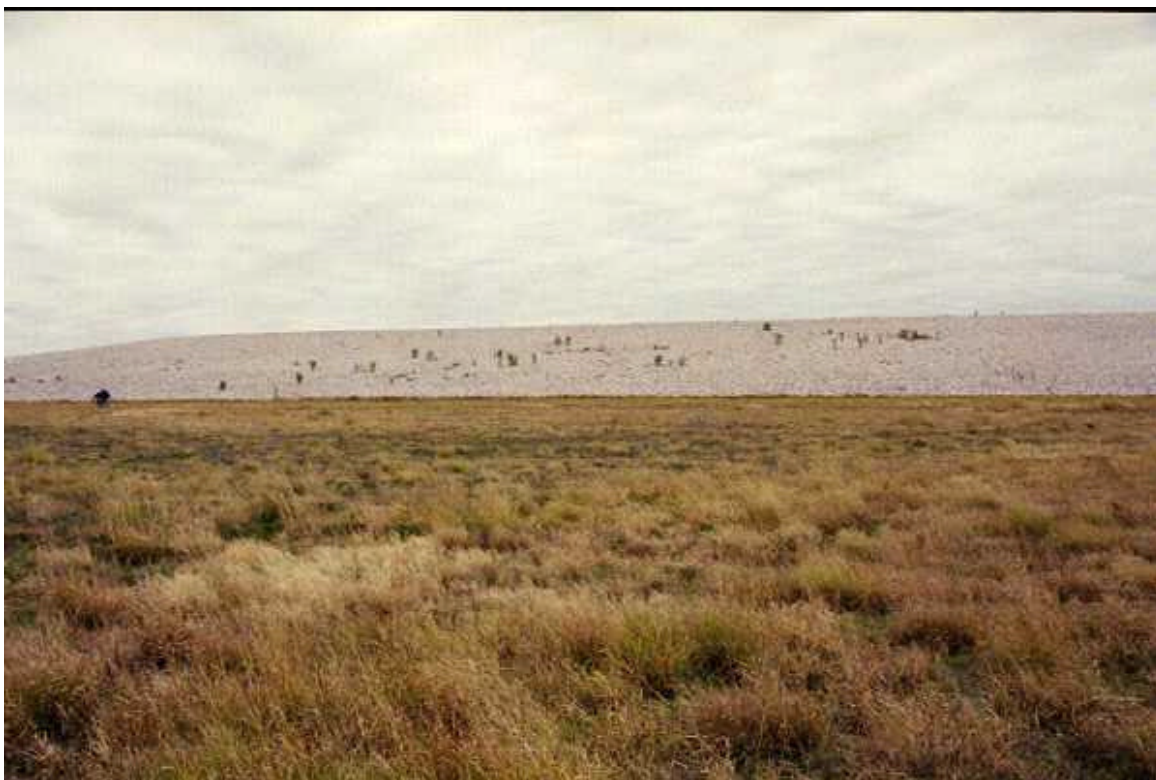
Small trees and bushes have been establishing for several years on the side slopes of the disposal cell (PL-1). Some, like greasewood and palo verde, are deep rooted. The plants give the disposal cell an unkempt appearance. DOE retained a local contractor to remove vegetation from the side slopes on an ongoing basis. Control measures are performed annually or as needed.

PL-1. Reference Photograph of Vegetation on Southeast Side Slope

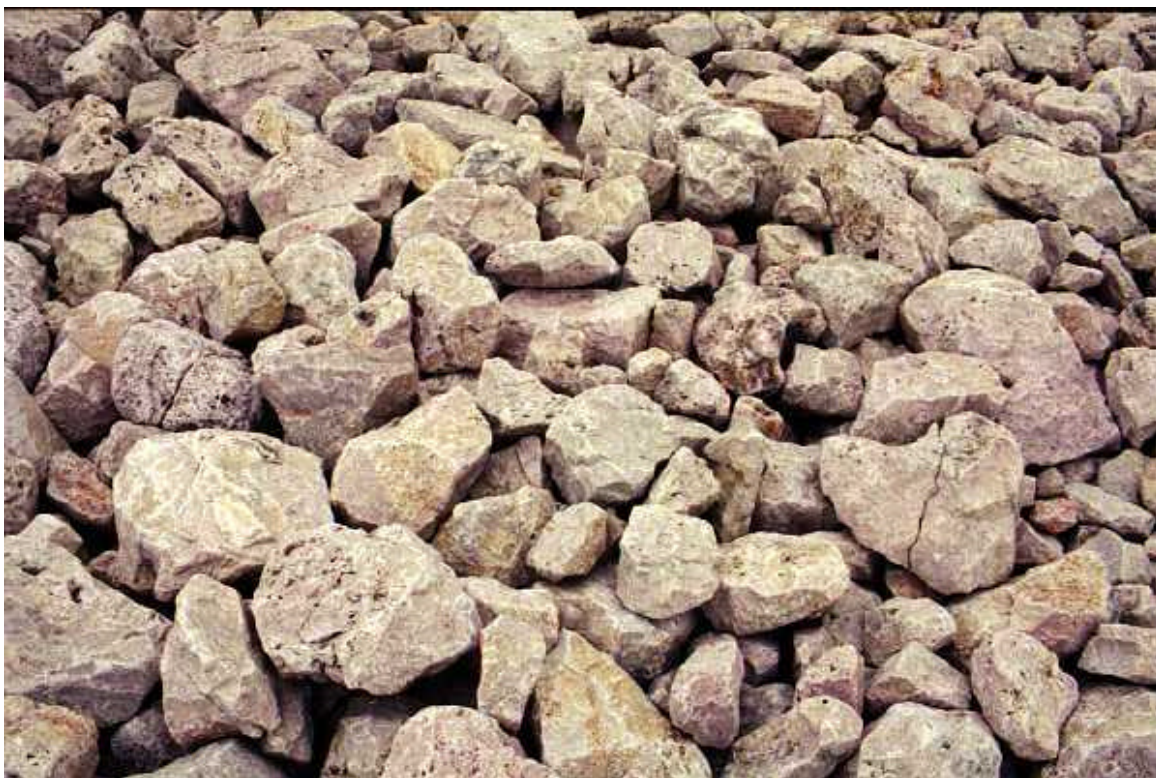
The side slopes of the disposal cell are armored with riprap, which overall is in excellent condition. Over the last 2 years, inspectors have noted that a very small percentage (less than 1 percent) of the riprap is cracked or broken (PL-2). It is not clear whether the cracks are recent or just recently noticed. None of the broken pieces appear to be more weathered or less durable than the unbroken rocks. Current assessment is that cracks are the result of stresses induced in the rock during quarrying and are not caused by chemical or physical weathering. Although inspectors will continue to note the condition of the rock, further cracking or breaking of the rock is not expected.

PL-2. Fractured Riprap on Southeast Side Slope
